UNDERWATER BRIDGE INSPECTION REPORT

STRUCTURE NO. 66515

CANNON RIVER

DISTRICT 6 - RICE COUNTY

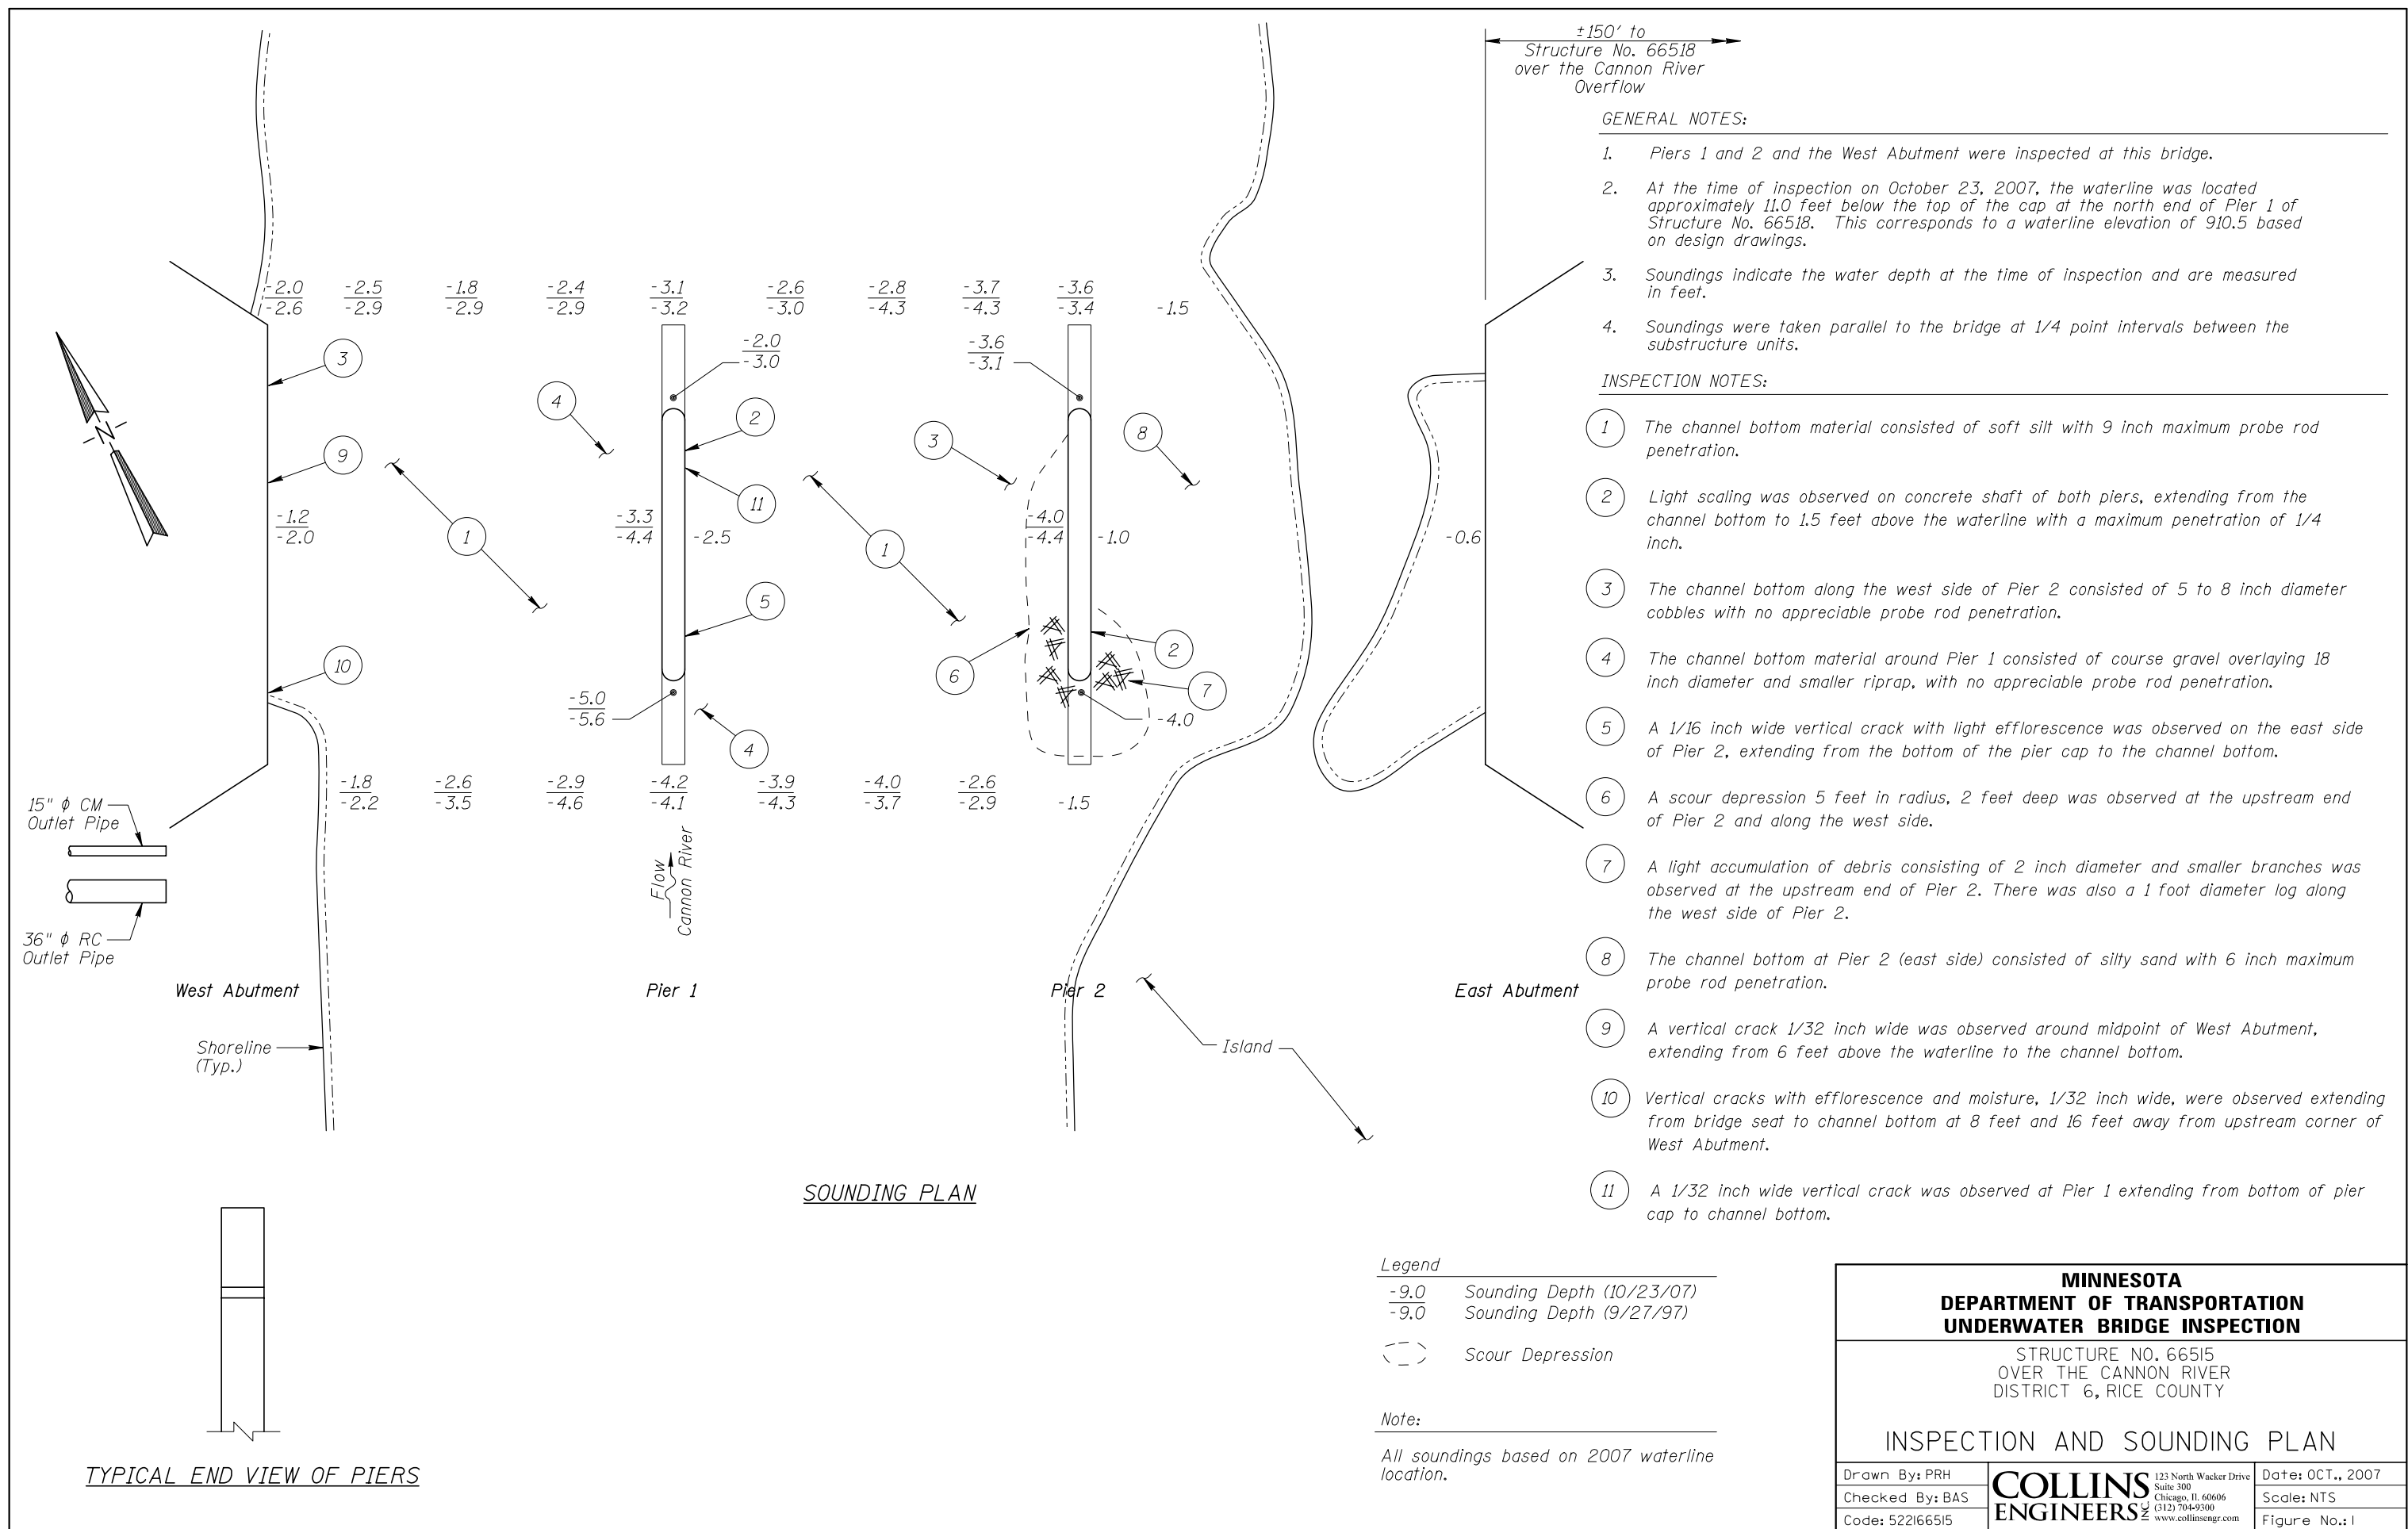
UPSTREAM FASCIA PROFILE
Vertical Scale: 1"=20'-0"

REMARKS: The concrete was smooth and sound and in good condition with light scaling from the channel bottom to 1.5 feet above the waterline with ¼ inch maximum penetration. There were also minor cracks on the pier shafts and abutment walls. A scour depression 5 feet in radius, 2 feet deep was observed at the upstream end of Pier 2 and along the west face. A light accumulation of timber debris consisting of 2 inch diameter and smaller logs and branches was observed at the upstream end of Pier 2. There was also a 1 foot diameter log along the west side of Pier 2.

Reinspect the submerged substructure units at the normal maximum recommended (NBIS) interval of five (5) years.
